Manhole Inspection Summary

Manhole # S71U__007MH

Insp Date: **4/18/08 3:50 PM**

Location Address: **1805 Dundalk Ave.**

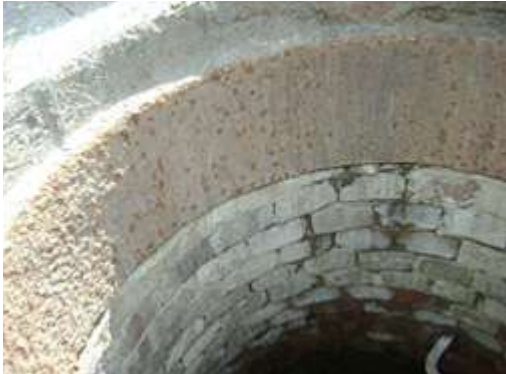
Defect 1

cracked mortar in barrel

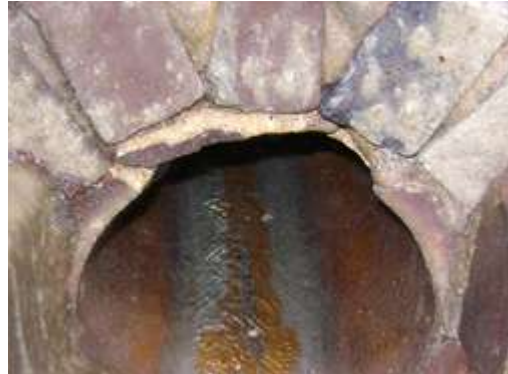
Defect 2

crack multiple 10:00- 2:00 on outgoing 12

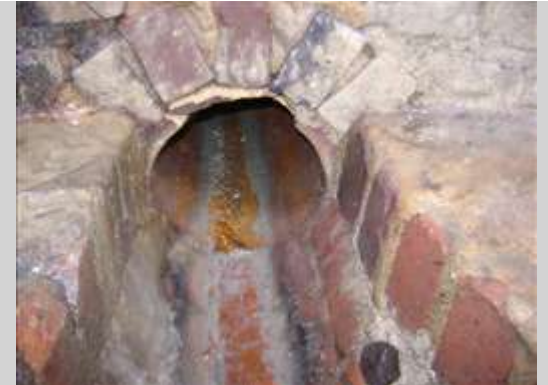
12 O'Clock Outflow

Pipe Height: **8.4** (in.) Rod and Bar (Angled)
Pipe Material: **Clay** ☐ Pipe Lined
Invert Depth: **6.17** (ft.) Flow Characteristics: **Slow**
Deposits: ☒ None ☐ Mud ☐ Sludge ☐ Debris ☐ Grease
Silt Depth: (in.) Deposits Extent:
Infiltration: **None** Pipe Seal Cond: **Sound**

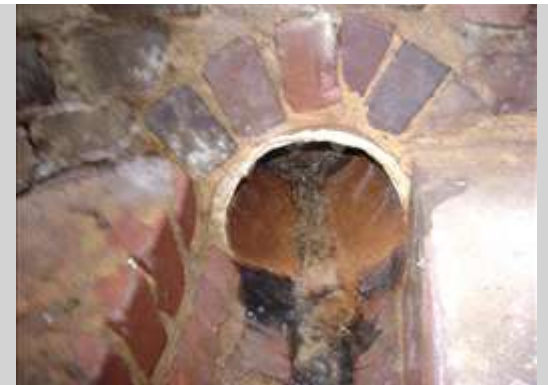
4 O'Clock Inflow

Pipe Height: **8.4** (in.) Rod and Bar (Angled)
Pipe Material: **Clay** ☐ Pipe Lined
Invert Depth: **5.83** (ft.) Flow Characteristics: **Slow**
Deposits: ☒ None ☐ Mud ☐ Sludge ☐ Debris ☐ Grease
Silt Depth: (in.) Deposits Extent:
Infiltration: **None** Pipe Seal Cond: **Sound**

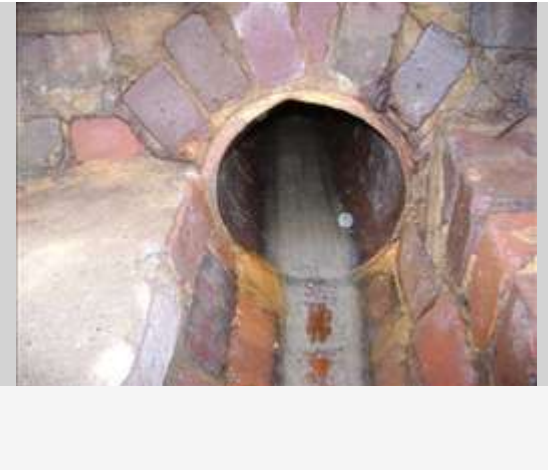
6 O'Clock Inflow

Deposits: ☐ None ☐ Mud ☐ Sludge ☐ Debris ☒ **Grease**

Silt Depth: **0.125** (in.) Deposits Extent: **Light**
